This errata sheet provides updated information on known device issues affecting Cyclone® IV devices.

Table 1 lists specific Cyclone IV issues, and which Cyclone IV devices are affected by each issue.

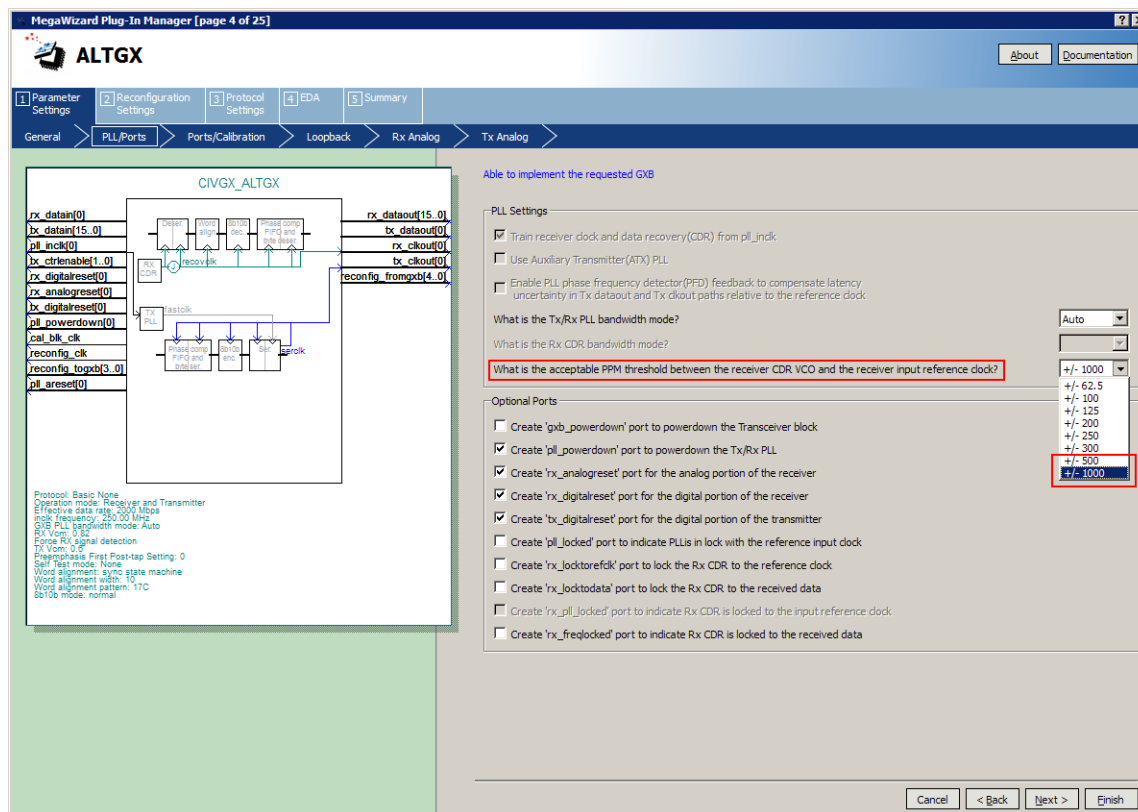
Figure 1. Programmable PPM Detector Options in the ALTGX MegaWizard Plug-In Manager

The  $\pm 500$  PPM and  $\pm 1000$  PPM options for the Programmable PPM Detector feature in the ALTGX MegaWizard™ Plug-In Manager, as shown in [Figure 1](#), are no longer supported in the Quartus II software version 10.0 SP1 and later. These options are removed because the programmed PPM threshold values exceed the receiver CDR PPM tolerance between the upstream transmitter reference clock and the local receiver reference clock.

Designs compiled with the Quartus II software version 10.0 and earlier may have a link failure risk when the receiver is operating in a system that has  $\pm 500$  PPM or  $\pm 1000$  PPM differences for the reference clock frequencies between the upstream transmitter and the local receiver. Using CDR Manual Lock mode does not overcome the link failure risk.

For a receiver design that has the  $\pm 500$  PPM or  $\pm 1000$  PPM options selected in the Programmable PPM Detector feature, Altera recommends evaluating the system operation with different options, ranging between  $\pm 62.5$  PPM and  $\pm 300$  PPM. To change the **Programmable PPM Detector** option, regenerate and recompile the ALTGX MegaWizard Plug-In Manager design file with the supported options.

If you compiled your designs using a Quartus II software version prior to 10.0 SP1, and you have selected the  $\pm 500$  PPM or the  $\pm 1000$  PPM option for the Programmable PPM Detector feature, the Quartus II Analysis and Synthesis error will be reported in the Quartus II software version 10.0 SP1 and later.
