PIC18F04/05/14/15Q41 Silicon Errata and Data Sheet Clarifications

The PIC18F04/05/14/15Q41 devices that you have received conform functionally to the current device data sheet (DS40002242D), except for the anomalies described in this document.

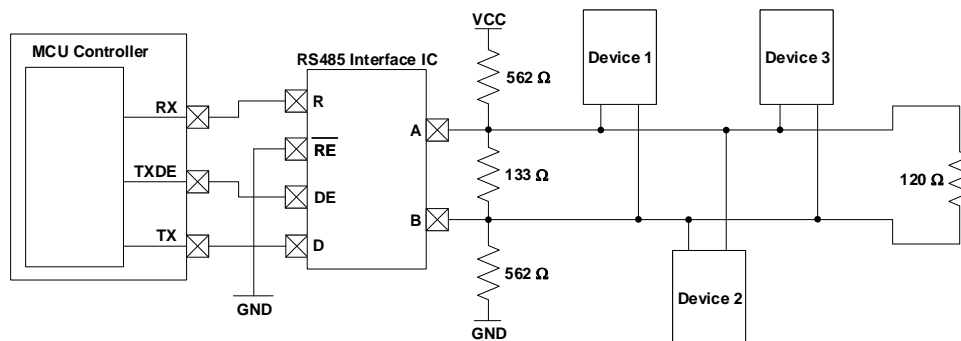
1.6.1 UART TXDE Signal May go Low Before The STOP Bit Has Been Entirely Transmitted.

The UART Transmit Drive Enable (TXDE) signal could potentially transition into a low state before the UART STOP bit has been entirely transmitted due to the effects of parasitic capacitance on the TX line. In some applications, this could result in communication being prematurely terminated due to the TXDE bit going low before the STOP bit has had enough time to settle.

In order to ensure that the STOP bit settles into its final logic state before the TXDE signal transitions low, a biasing circuit can be implemented. A biasing circuit allows the TX line to either be driven high or low, rather than being left in a floating tri-state mode where prolonged rise or fall times could lead to communication being disrupted. This bias circuit should only be implemented on one end of the serial bus, and a termination resistor should be used on the other end. The figure below show an example of a bias circuit that can be used to achieve this. Please note that the resistor values used in this circuit are recommendations, and that the actual resistor values required may vary based on the application.
